THE WOLFF COMPANY
ISSAQUAH GATEWAY
SENIOR HOUSING

CITY OF ISSAQUAH, WASHINGTON

ISSAQUAH SENIOR SITE

OVERALL TREE
PRESERVATION PLAN

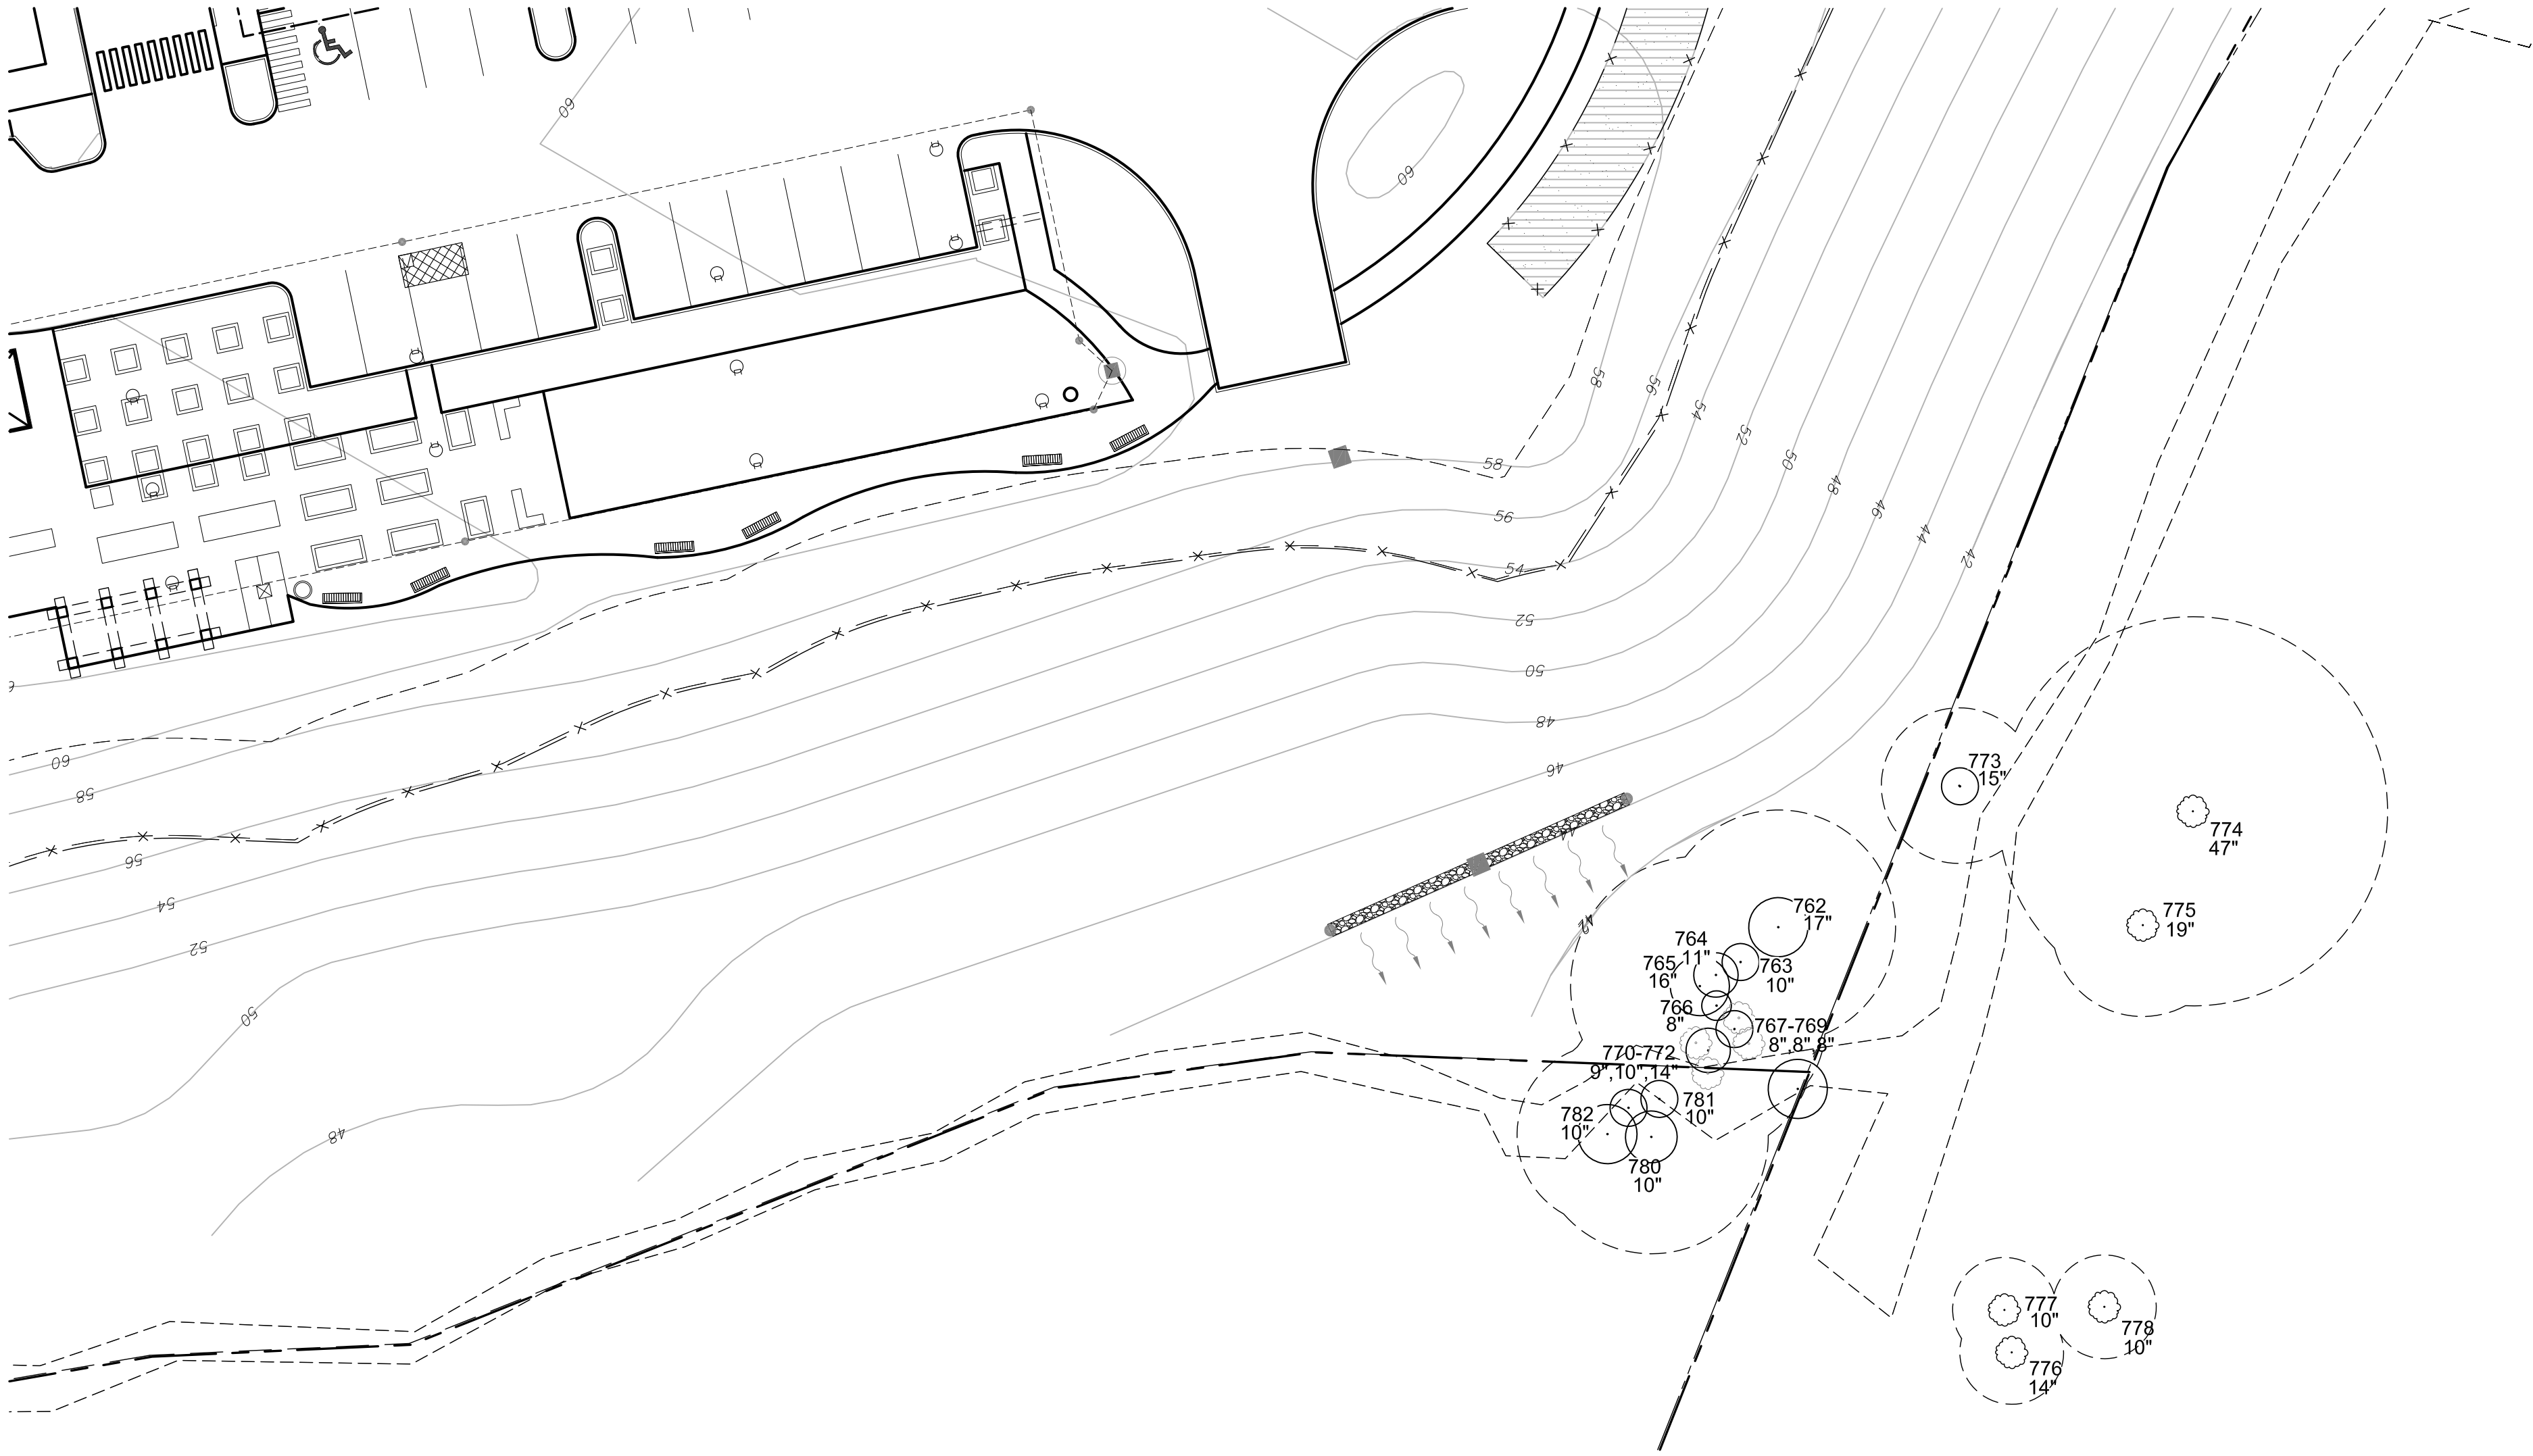
1 TREE PRESERVATION PLAN - ENLARGEMENT 3
SCALE: 1"=20'-0"

- VIABLE TREES TO BE REMOVED
- NON-VIABLE TREES TO BE REMOVED
- VIABLE TREES TO REMAIN AND PROTECT IN PLACE
